EXPERIMENTAL EVALUATION OF UHPFRC SLABS SUBJECTED TO CONTACT EXPLOSION UNDER VARIOUS LOADING CONDITION

This paper presents outcomes of an experimental program focused on blast performance of the ultra-high performance fiber concrete (UHPFRC) slabs material. Twenty-eight UHPFRC slabs, made of two different premixes were loaded by blast (contact and close-in). The spall development and velocity of the ejected debris were measured. Spall development was measured by high speed camera and velocity by photon doppler velocimetry. Inner damage of each specimen measured with the use of ultrasonic pulse velocity method. Results from PDV and high-speed cameras and ultrasonic pulse velocimeter will be presented separately.

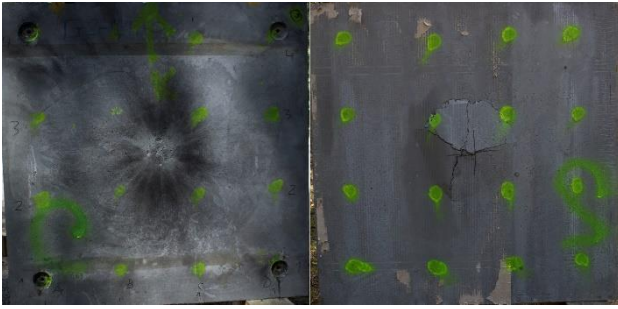
Specimen Nr. 4 (Fig. 4) experienced visible damage only on the soffit. Contact side was not damaged at all, even the cracks were not observed on the specimen surface. On the soffit there was an area heavily protuberant out of the specimen. This area was bounded by the peripheral crack and divided by four radial cracks. These cracks proceeded from the centre of the area towards its edge but did not propagate further. Therefore, the surface outside the protuberant area was not damaged at all.

Fig. 4: Specimen Nr. 4 contact side (left) and soffit (right).

As already mentioned, the specimens Nr. 4 and 11 were rated as with no damage results, surfaces on the soffit were cracked and protuberant from the specimen. Regardless the absence of the damage on the contact side, both cases were on the boundary line between crater failure mode and crater and spall damage mode. Sometimes these results are classified as threshold spall. Despite that both specimens were made of same material and were loaded by the same conditions, some differences in the results were observed. These differences

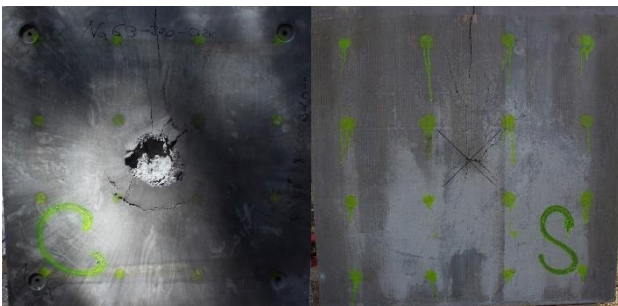
Specimen Nr. 28 (Fig. 5) experienced damage on the contact side was 160-170 mm in diameter with depth of crater 33 mm. Except for the crater, there were obviously peripheral cracks in the distance 80 mm from the edge of the crater. Area marked by the peripheral crack was damaged by the few radial cracks with one reaching edge with handlings. Soffit side was damage in the same manner as in the case of specimens Nr. 25 and 26. The area was not spalled but the cracks were clearly marking the area which would be spalled. Radial cracks proceeded in the centre of the surface and some of them propagated towards the edge with the handlings copying the cracks on the contact side.

Fig. 5: Specimen Nr. 28 contact side (left) and soffit (right).

Specimens Nr. 25, 26 and 28 present the influence of the scaled distance. Specimen Nr. 28 with the lowest scaled distance and highest scaled distance, suffered more damage on the contacts than specimens Nr. 26 and 25. The specimen Nr. 26 had only lower scaled distance and scaled thickness as specimen Nr. 25 but it was more damaged on the both sides. Specimen Nr. 25 was not damaged at the soffit despite the specimen lowest thickness.

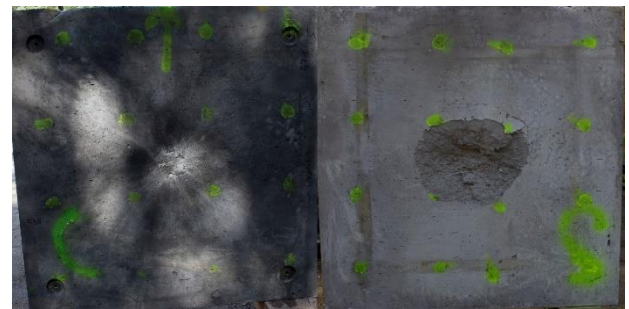
First group contains specimens Nr. 9 (Fig. 6), 10, 17 and 21. Each specimen was 100 mm thick. Scaled distance was very similar to each other. Specimens in this group were damaged only by the spall and no crater occurred. In the case of specimen Nr. 10 and 21, spall diameter was very small with diameter 30 – 60 mm and 40 mm, respectively. The depth was maximally 10 mm and there was no damage on both surfaces except from the before mentioned small spall. Specimens Nr. 9 and 17 were damaged on the soffit by the spall with diameter 265 – 318 mm and 235 – 300 mm. Depths were 33 mm and 15 mm. There were no cracks observed on all specimens.

Fig. 6: Specimen Nr. 9 contact side (left) and soffit (right).

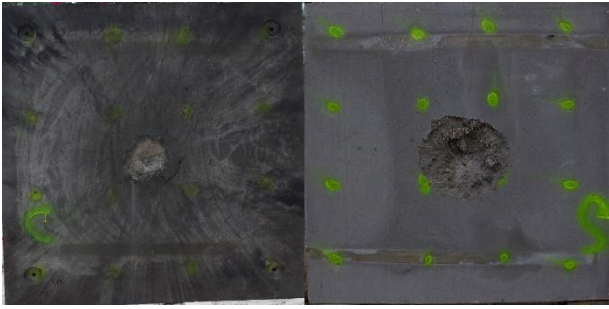
Second group contains specimens Nr. 2 (Fig. 7), 16 and 22. All the specimens were 100 mm thick. Damage of all specimens can be described as pure crater and spall. There were no cracks on both surfaces at all. Specimen Nr. 2 ended with crater with depth 27 mm and diameter 115 - 160 mm. Spall was 55 mm depth with diameter 255 – 280 mm. Specimen Nr. 16 resulted in crater with depth 10 mm and 70 – 90 mm wide in diameter. Bottom surface was damaged by the spall 210 – 270 mm in diameter and 34 mm depth. In case of specimen Nr. 22, specimen was damaged by the crater with diameter 70 – 100 mm and 15 mm depth. Spall damage was 35 mm depth and 250 – 280 mm in diameter. All the previously described damages were circular in their shapes.

Fig. 7: Specimen Nr. 2 contact side (left) and soffit (right).

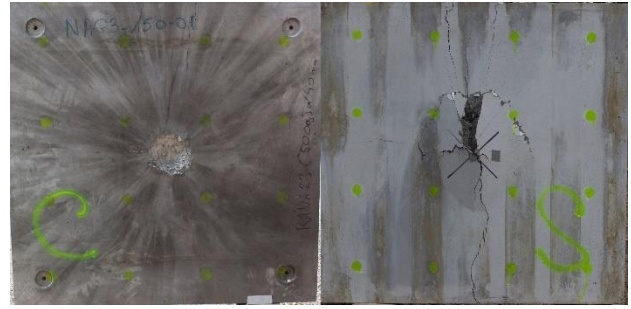
Third group consists of specimens Nr. 6, 7, 18, 19, 23 (Fig. 8) and 27. Specimen Nr. 23 was carried on specimen with thickness 150 mm. In case of specimen 19, specimen was 200 mm thick. Other shots were performed on specimen 100 mm thick. Damage of these specimens can be described as crater and spall with one main radial crack and only few or no secondary radial cracks and peripheral cracks. Specimen Nr. 6 was damaged by the crater with diameter 145 – 158 mm and depth 24 mm. Soffit was damaged by spall with diameter 242 – 290 mm and depth 74 mm. Contrary to contact side with only one radial crack, soffit was damaged by one main radial crack and few shorter and tighter. Specimen Nr. 7 ended with the crater damage with depth 38 mm and 135 – 156 mm in diameter. Spall damage depth was 57 mm and diameter 260 – 286 mm. Only one radial crack appeared on both surfaces. Specimen Nr. 18 ended with the crater depth 38 mm and diameter 185 – 190 mm. Spall diameter was 260 – 300 mm and depth 60 mm. As well as in case of specimen Nr. 7, only one radial crack appeared on both surfaces, but the crack was thinner and accompanied by few peripheral cracks on the contact side. Specimen Nr. 19 ended with almost same damage depth on both surfaces; 62 mm on the contact side and 65 mm on the soffit. Damage on the contact was perfectly circular; 200 mm in diameter. On the soffit, extend of the damage was higher in comparison to other specimens with diameter varying from 425 to 535 mm. As well as in the specimen 7, specimen 19 was cracked only by one radial crack identical on both surfaces. Damage of the specimen 23 can be described as almost perfect circle crater with diameter 135 – 150 mm and depth 40 mm. There was one radial crack on the contact side. Contrary to the other specimens in this group, soffit was damaged by few radial cracks. One proceeded from the spall and reached the cross edge without handlings. Other cracks were oriented in the direction towards the edge with handlings. None of the cracks propagated through the specimen thickness. Spall damage was mostly hold by the fibers and therefore did not spall completely out of the specimen. Spall diameter was 335 – 380 mm and depth in fully spalled area was 40 mm. Specimens Nr. 27 ended with crater with depth only 7 mm and diameter 123 – 135 mm. Spall damage was deeper, 61 mm, and wider, 355 – 379 mm. Both surfaces were cracked. On the contact side, only one radial crack appeared. It started at the edge with handlings and propagated towards the damage centre but did not reached it. Soffit was cracked by three cracks behaving in the same manner as the crack on the contact side.

Fig. 8: Specimen Nr. 23 contact side (left) and soffit (right).

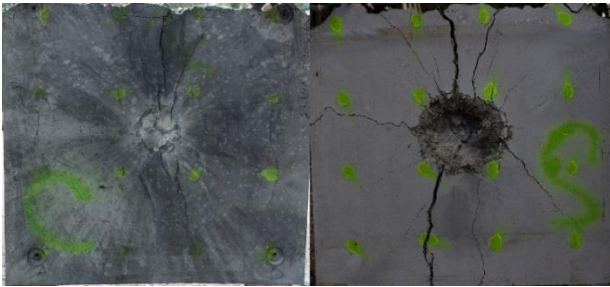
Last group consists of specimens Nr. 3, 5 (Fig. 9), 8 and 15 (Fig. 10). Two specimens (Nr. 8 and 15) were carried out on specimen with thickness 200 mm. Specimen Nr. 3 was performed on specimen 150 mm thick and specimen Nr. 5 on 100 mm thick specimen. All these specimens were damaged by the crater and spall. In addition to this a lot of cracks on at least one surface were observed. Specimen Nr. 3 ended with crater depth 46 mm and diameter 161 – 185 mm. Contact surface was damaged by the peripheral cracks oriented in longitudinal direction. These cracks were not continuous but reached the edge with handlings. Peripheral cracks were not observed on the contact side. Soffit was damaged by the 59 mm depth spall; diameter of spall damage was 257 – 294 mm. Surface was damaged by the radial cracks as well. Two main cracks were directed in longitudinal direction. Crack, which propagated towards the edge with handlings, reached the edge with handlings. This edge was also damaged by more cracks oriented in cross way. In addition to these main radial cracks, other radial cracks propagated from the damaged area. However, these cracks did not reach the side edge. Surface layer between the cracks was protuberant from the specimen but fibers held them. Shot 5 created crater on the contact side with diameter 130 – 158 mm and depth 10 mm. Cracks observed on the surface were peripheral and radial. Peripheral cracks were mostly located near the longitudinal edges. Radial cracks were oriented in the same manner as in case of specimen Nr. 3. Main cracks propagated in the damaged area. Soffit was damaged by the spall with diameter 250 – 293 mm and depth 60 mm. Only radial cracks were observed on the soffit. Contrary to most of the specimens, peripheral cracks on the specimen loaded by shot 5 were oriented in all direction. However, the wide crack was oriented in longitudinal direction and propagated towards both cross edges. Few other cracks reached the specimen's edges as well. Shot 8 caused very similar damage as in case of specimen Nr. 3. Crater depth was 45 mm, diameter 167 – 185 mm. Soffit damage diameter was 360 – 430 mm and depth 65 mm. System of the cracks was similar to the specimen Nr. 3 with one main radial crack oriented in longitudinal direction and other shorter radial cracks. Peripheral cracks were not observed at all. Shot 15 caused crater with diameter 180 – 220 mm and depth 25 mm. Edges with handlings were damaged by cross and radial cracks which proceeded from the crater. Spall on the soffit was rather large-size with diameter 400 – 500 mm and depth 60 mm. However, only middle part was ejected from the specimen. Other area was damaged by the radial cracks, bulged out of specimen but not separated from the slab. Area of spall was clearly marked by the peripheral cracks. One main

crack propagated through the specimen from the edge with handlings to the opposite one. Other radial cracks propagated mostly towards the edge with handlings which were damaged by the cross section.

Fig. 9: Specimen Nr. 5 contact side (left) and soffit (right).

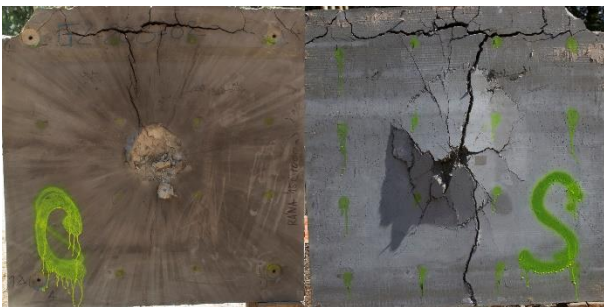
Fig. 10: Specimen Nr. 15 contact side (left) and soffit (right).

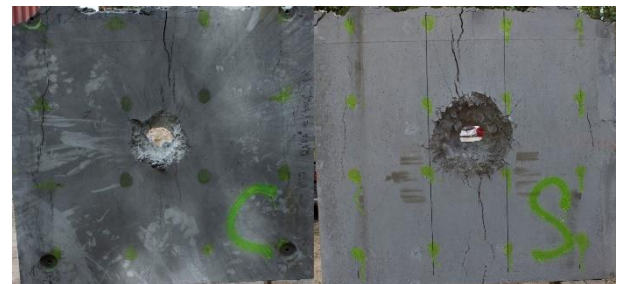
Specimen Nr. 12 (Fig. 11) and 13 had identical arrangement as the specimen Nr. 1. Therefore, these specimens were used to set the statistical scatter (discussed later) of results with similar scaled thickness and scaled distance. Visually damage of both specimens was very similar to the specimen Nr. 1. Crater diameter was 170 - 200 and 180 - 200 mm, respectively. Breach diameter was 55 - 74 mm in case of specimens Nr. 12 and 80 - 118 mm in case of specimen Nr. 13. Damage depth on the contact side was 40 mm in case of specimen Nr. 12 and 30 mm in case of specimen Nr. 13. On both specimen's contact sides there was one main longitudinal crack proceeding from

the damage area to the edge with handlings and secondary cracks located in the opposite direction. These radial cracks were accompanied by the peripheral cracks on the longitudinal edges. On the soffit, damage diameter varied between 265 - 280 mm and 290 - 300 mm, respectively. System of the cracks was similar to the contact side. One main crack directed in the longitudinal crack proceeded from the damage area to the edge with handling and few secondary cracks proceeded from the opposite direction. These cracks were accompanied by the peripheral cracks located near the longitudinal edges. In both cases the delamination of the upper edge with handling occurred. Examination showed absence of the fibers in this area. This phenomenon was probably caused by the concreting technique.

Fig. 12: Specimen Nr. 11 contact side (left) and soffit (right).

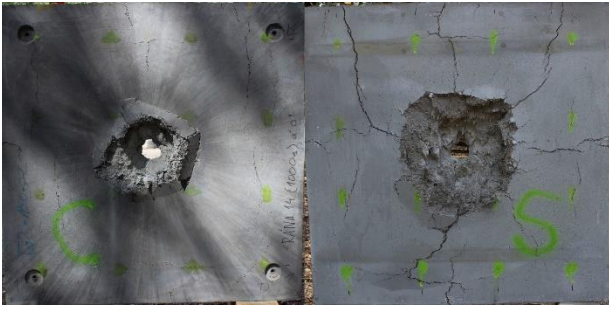
Specimen Nr. 14 (Fig. 12) ended in breach with diameter 56 - 58 mm. This was in contrary to the surface damage diameter very small. On the contact side, there was a crater with diameter 230 - 300 mm and depth 40 mm. There were no perpendicular cracks which would have been proceeded from the damage area. However, the surface was heavily damaged by the peripheral cracks near the edges of specimen. Central damaged area varied from the other specimens. Surface layer on the boundaries of the damaged area was separated from the specimen but due to fibers did not fall out. Therefore, surface on the boundaries of the damage area was protuberant from the specimen. Damage on the soffit was different from the other specimens. Spall damage was relatively large with diameter 460 - 410 mm and depth 110 mm. Radial crack system was typically with six radial cracks uniformly distributed on the surface. All cracks propagated towards the side edge. Contrary to the contact side, there was no peripheral cracks at all.

Fig. 12: Specimen Nr. 14 contact side (left) and soffit (right).

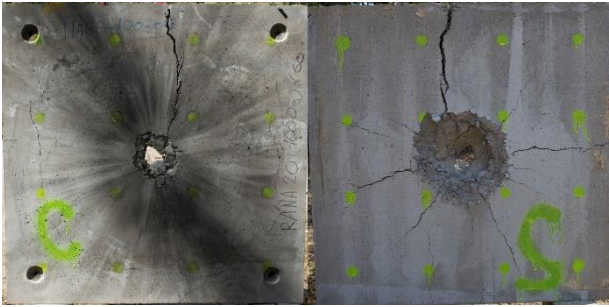
Specimen Nr. 20 (Fig. 13) ended in the breach with diameter 40 - 50 mm. Crater diameter was 140 - 180 mm but its depth was minimal and evaluated as 0 mm. Therefore, almost all the damages of the specimen were caused by the spall, on the contact side only the surface was damaged. There was only one radial crack connecting the damaged area and edge with handlings. This crack run through the specimen thickness. Therefore, on the soffit this main crack was also evident. Contrary to the only one radial crack, there were peripheral cracks situated to the almost perfect circle. Opposite surface was damaged by the spall with diameter 295 - 310 mm. Depth of the damage was evaluated as the full specimen thickness. There was no peripheral crack but there were a lot of radial cracks. Except for the before mentioned main one, all cracks were situated near longitudinal edges or cross edge without handlings. No crack reached the edge.

Fig. 13: Specimen Nr. 20 contact side (left) and soffit (right).

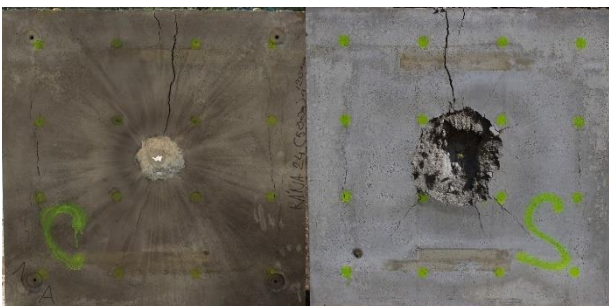
Specimen Nr. 24 ended with the smallest breach diameter, 13 – 24 mm, from all the breach specimens. Contrary to the specimen Nr. 20, the damage depth on the contact side was higher; 35 mm. Crater diameter varied from 145 mm to 170 mm. Crack's system was similar to the specimen Nr. 20, with one radial crack going through the specimen thickness and peripheral cracks. Soffit was damaged by the spall with diameter 295 – 310 mm and depth approximately 70 mm. Only the surface layer was spalled on the boundaries of the spall. At the distance approximately 20 – 50 mm from the edges of the damage, the depth abruptly increased to the full depth of spall. Crack's system was similar to the specimen Nr. 20 as well. It means only few short peripheral cracks and many radial cracks which proceeded from the spall but did not reach the edge of specimen.

Fig. 14: Specimen Nr. 24 contact side (left) and soffit (right).
